Fire resistance of extruded hollow-core slabs

Hertz, Kristian Dahl; Sørensen, Lars Schiøtt; Giuliani, Luisa

Published in:
Journal of Structural Fire Engineering

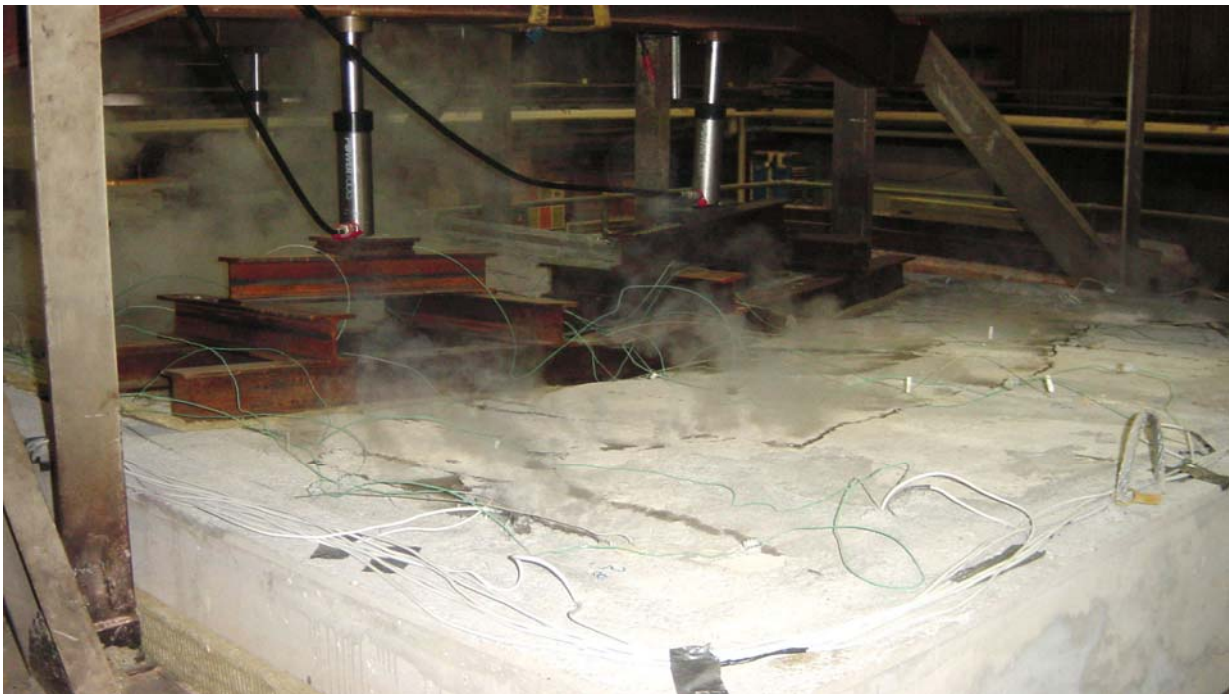
Figure 7. Cracks in top flange after approx. 15 min. Photo K. Hertz.

The midspan deflections are given in Figure 6. Substantial cracks were developed in top and bottom of the slab elements after 15 minutes (Figure 7), and the ISO 834 standard fire duration was assessed to be 25 minutes at this accredited test.

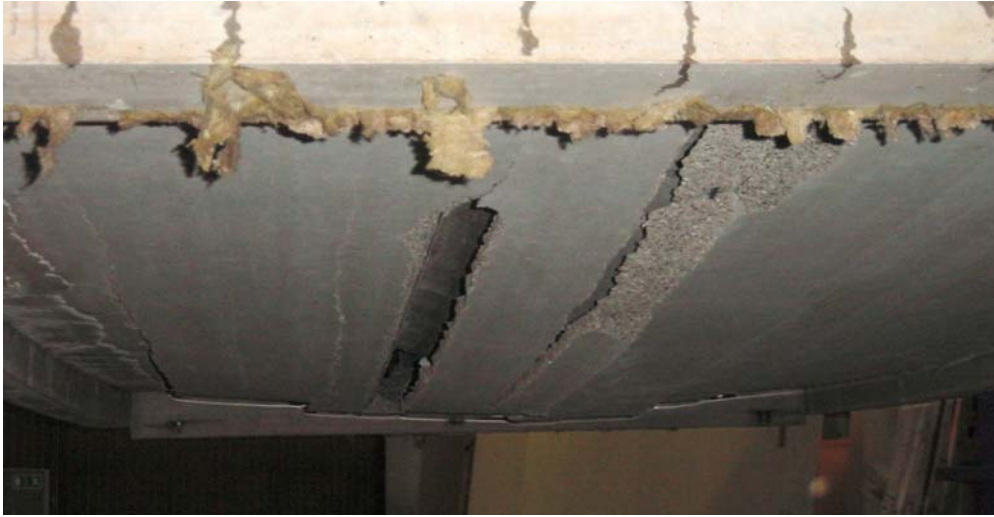
Figure 8. Damages after 25 minutes. Photo K. Hertz.

Lifting the element off the oven, it was seen that the bottom flange was partly fallen down and large cracks were developed to the other channels (Figure 8). No sign of shear failure was seen and the deflection indicated that the failure mode may have been bending. But as explained in the following, the failure modes of shear, anchorage, bending, and de-lamination may be results of the same deterioration of the slab.

Cracks appear along the decks under the channels after 10-15 minutes fire exposure and often the bottom flanges falls down, as shown for example in Figure 8.
